NASA-DoD Lead-Free Electronics Project

Joint Test Report - Final

December 2011

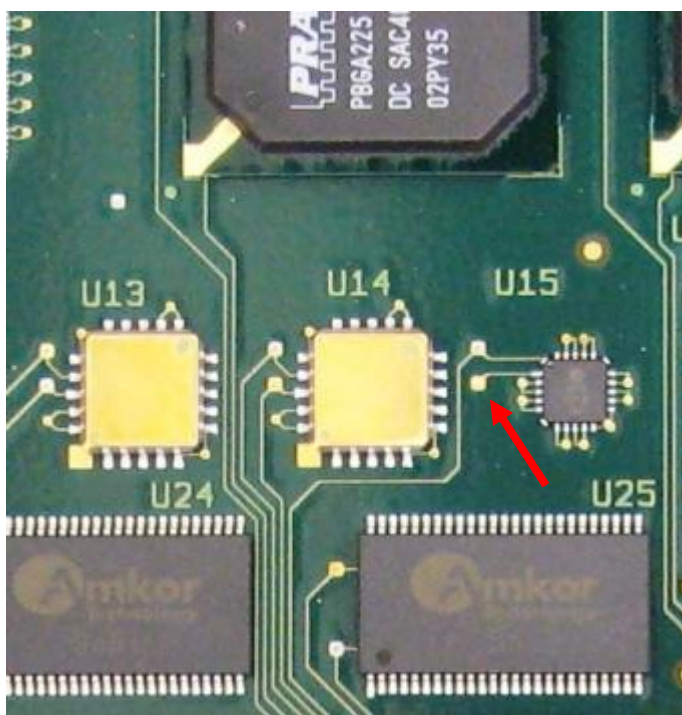
Figure 7 - Missing Trace, QFN – U15

Component location U15, a QFN, is missing a wire trace, Figure 6. During drafting, the trace was not included in the test vehicles drawing, Figure 7. Test data cannot be collected for this component unless a jumper wire is used in-place of the missing trace. Jumper wires were used for the thermal cycle test vehicles. For vibration, drop, mechanical shock and combined environments testing, it was determined that a jumper wire is not feasible. For the NSWC Crane rework test vehicles, QFN U15 is an active rework component. For drop and vibration testing, a jumper wire was attached to each U15 location to permit collection of test data (see Figure 8).

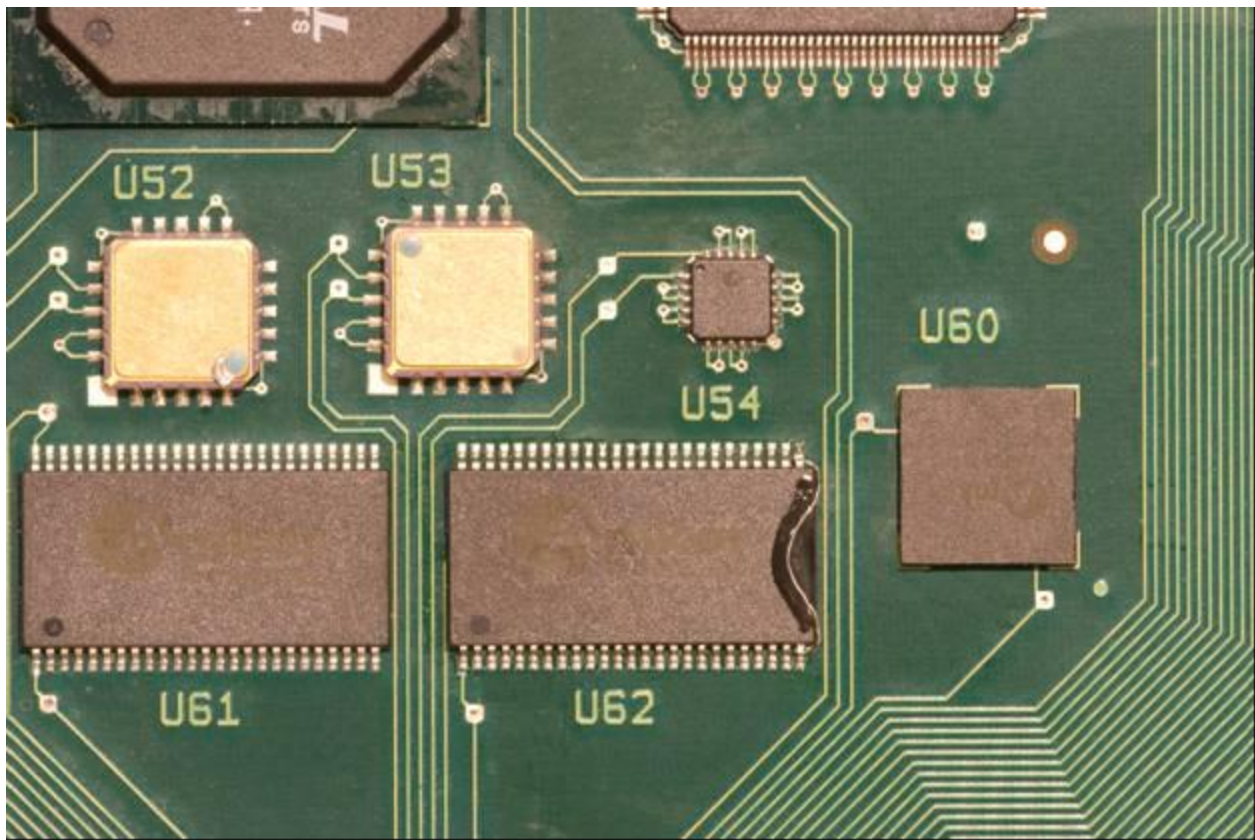
Figure 9 – TSOP Component Jumper

The TSOP-50 components were found to be missing internal wire bonds during incoming component inspection. Numerous solutions were discussed by the stakeholders of the NASA-DoD Lead-Free Electronic Project. One solution agreed to by the group, was to add a jumper to the components for a few of the test vehicles (Figure 9). This option would have had to be worked following assembly, requiring 2000 jumpers, and dealt with during rework operations. With the jumper, only half of the component would be working. Instead of using jumpers to solve the TSOP component issue, Lockheed Martin provided the funding required to purchase new TSOP components from Amkor through Practical Components. The jumper option was used on a very limited basis; thermal cycle test vehicle (SN110), vibration test vehicle (SN61), and drop test vehicles (SN80 and SN86).

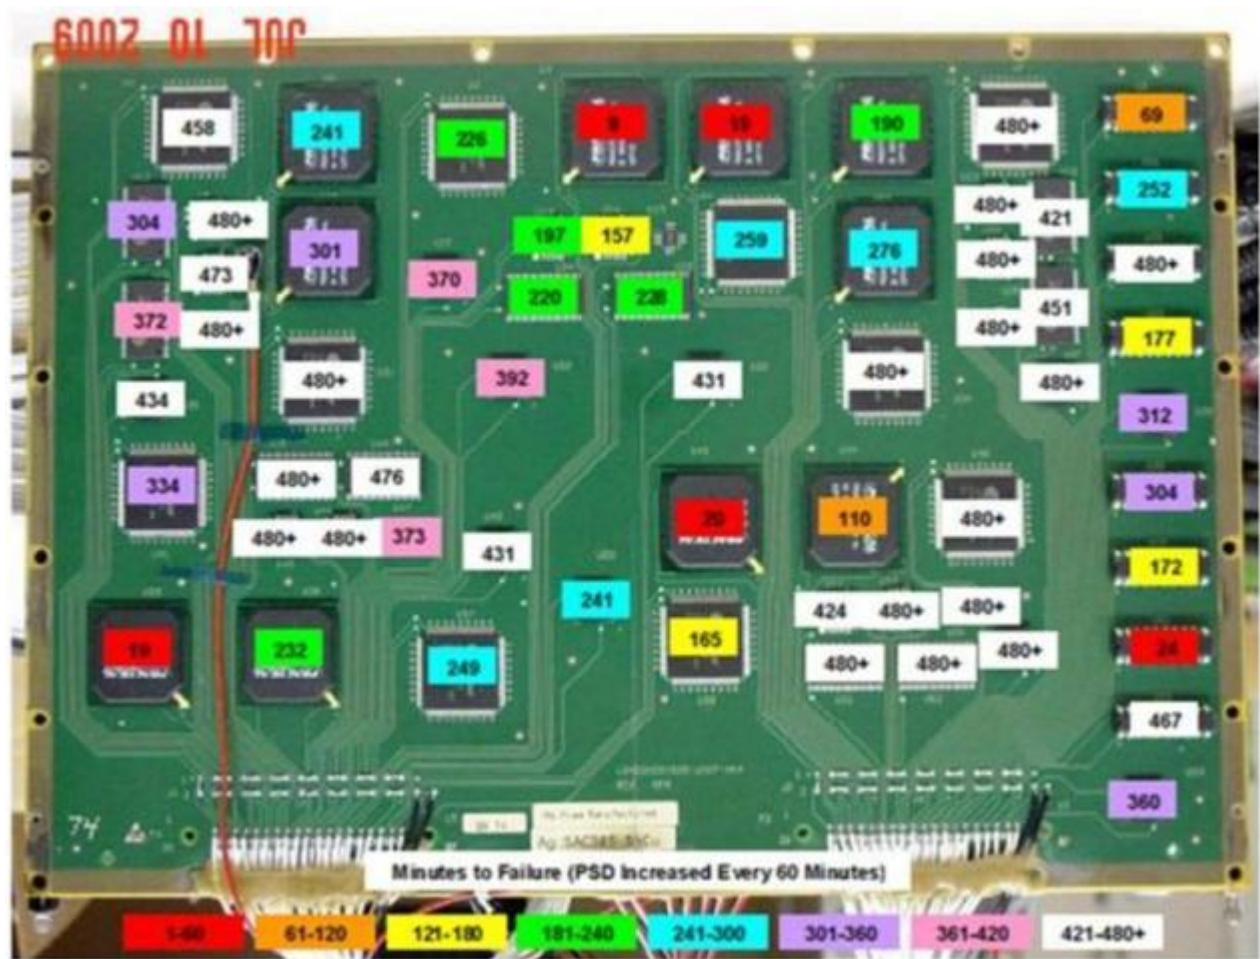
Figure 11 - Test Minutes Required for Components to Fail (Test Vehicle 74 Data)

Figure 11 shows when the components failed on Test Vehicle 74. The failures are colored coded according to how many test minutes were required to cause the failure (red = 1 to 60 test minutes; orange = 61 to 120 minutes; yellow = 121 to 180 minutes; green = 181 to 240 minutes; blue = 241 to 300 minutes; purple = 301 to 360 minutes; pink = 361-420 minutes; and white =

421 to 480+ minutes). In general, the components tended to fail first down the centerline and along the edges of the test vehicle (near the wedgelocks). Therefore, the first component failures coincide with the regions of highest strain as shown in Figure 12.

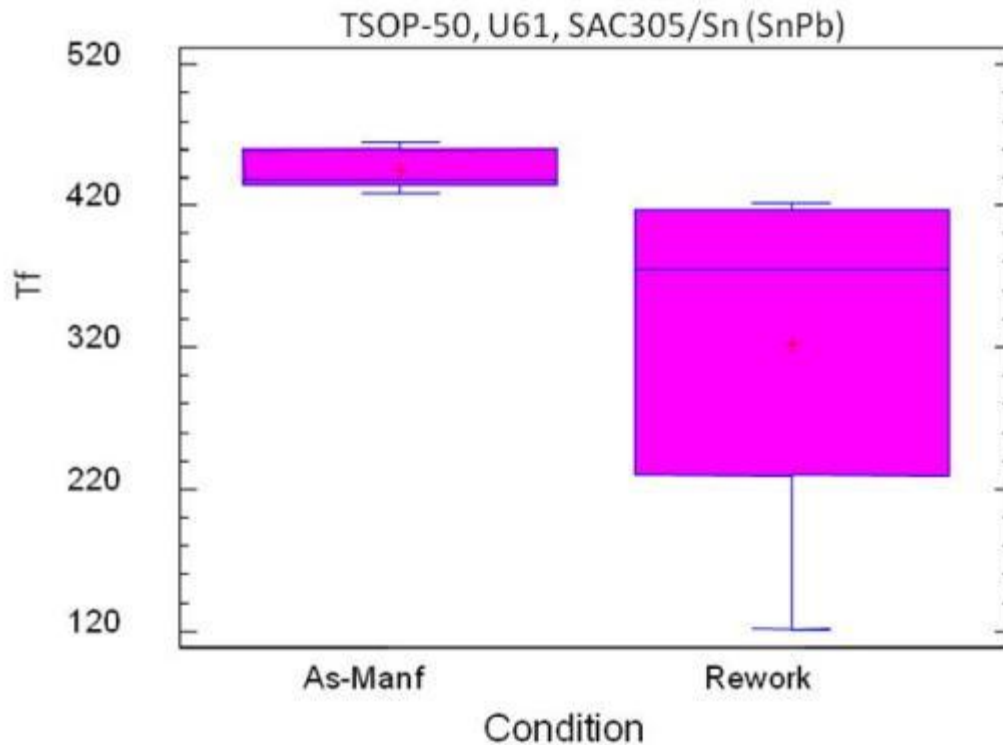
Figure 14 - Test results for U61, in the As-Manufactured Condition and after Rework

Starting with the cases where the reworked samples failed more quickly, there were two test runs where the reworked TSOP-50s did not perform as well as samples in the as-manufactured condition. In one run, the reworked parts failed 121 minutes earlier. This was U62, and the difference can be attributed to one outlier; an early life failure on just one reworked sample. Another TSOP, U61 failed an average of 95 minutes earlier after rework. The test results are shown in Figure 14.

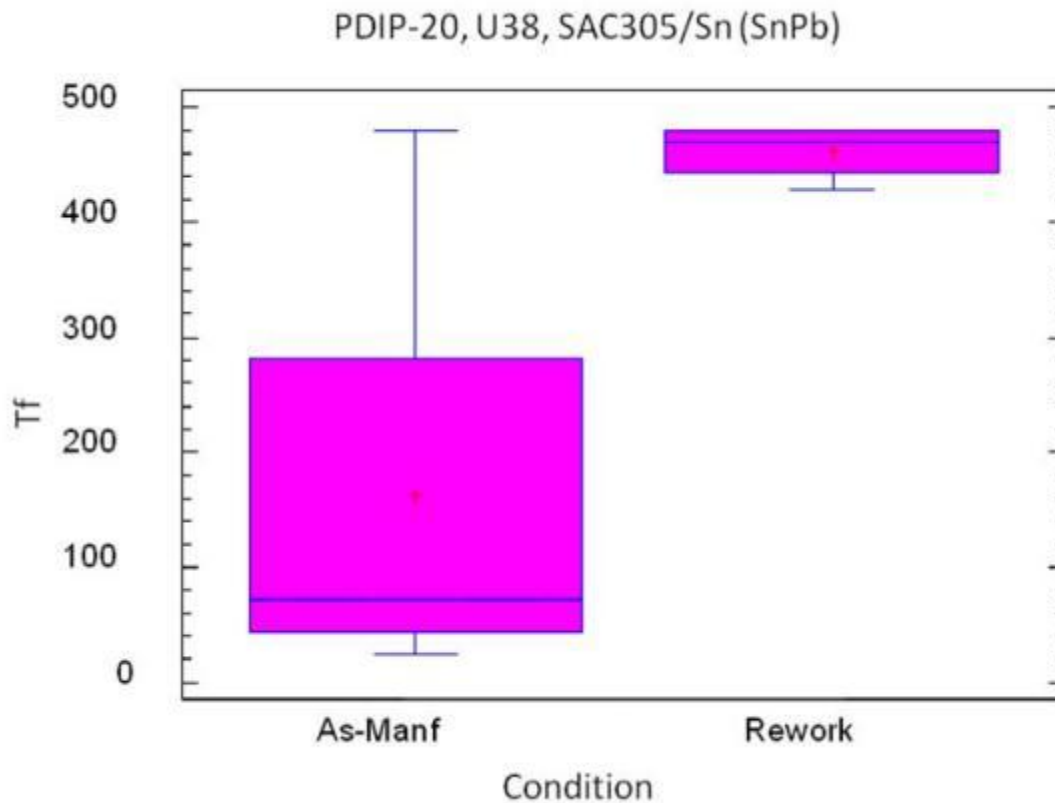
Figure 15 - Results of PDIP-20, U38 in As-Manufactured Condition and after Rework

In two cases, the reworked samples lasted much longer than as-manufactured samples. The most extreme example was a test run where PDIP-20, U38, lasted 300 minutes longer after rework. A graph of the results is shown in Figure 15.

These extreme results are due to three early life failures of the as-manufactured components, all failing in the first 80 minutes. The final as-manufactured sample survived the test, operating successfully after 480 minutes.

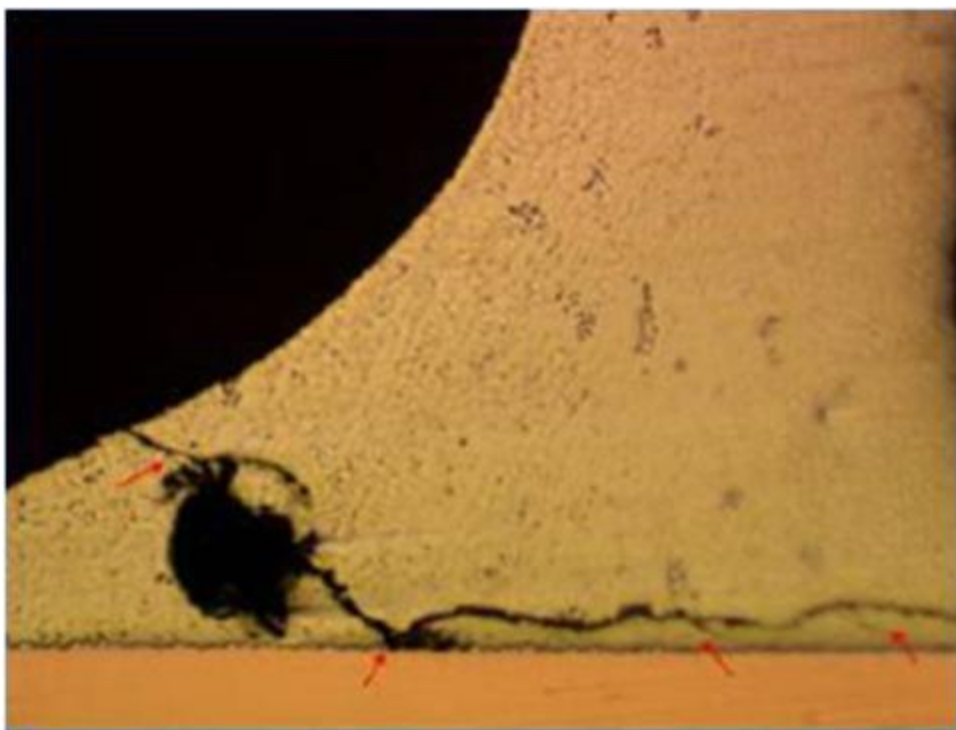
Figure 18 - SN67 U52, Left Side Pad

All of the tested CLCC-20s had SAC305 component finish. None of these solder joints were reworked. Solder cracks we observed around every solder joint. The cross sections of all CCLC-20 packages were performed on corner pads. Each cross section revealed cracking across the length of the solder, see Figure 17. SN67 also showed voiding, in this case the crack traveled along the void, see Figure 18.

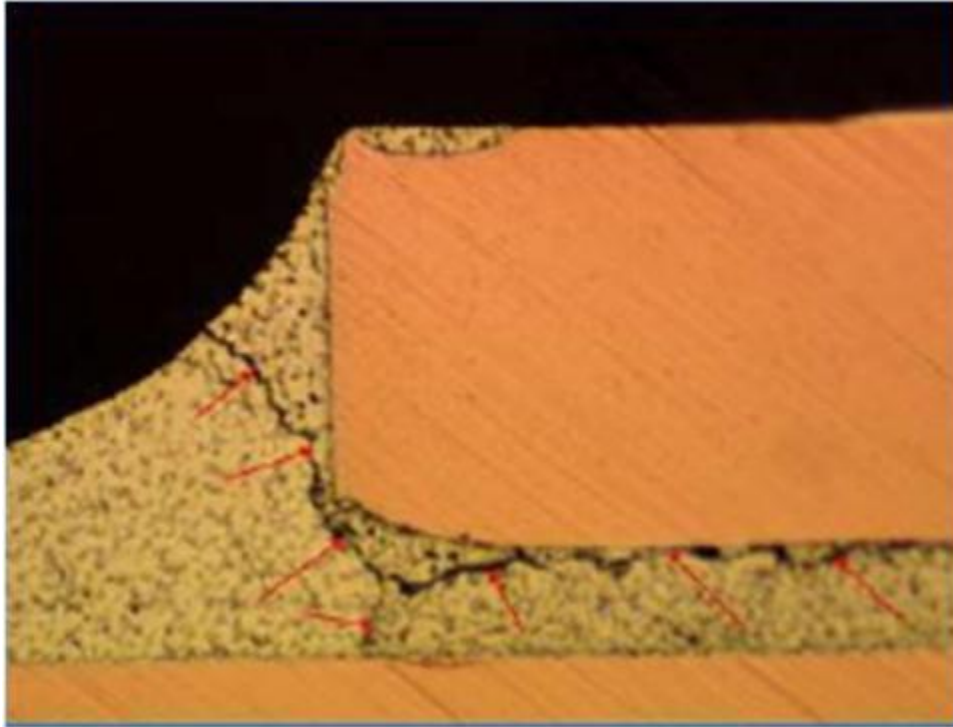
Figure 19 - SN63 U54, Left Side Pad

All of the QFN-20 packages were fabricated using Sn finish and were exposed to one or two reworks with SnPb solder. Approximately half of the solder joints exhibited cracks which ran along the component pad. There does not appear to be a correlation between the cracked solder and the number of re-work cycles to which the part was exposed. Cross sections of the QFN-20 packages reveal that the cracks propagated along the component pad, see Figure 19 and Figure 20.

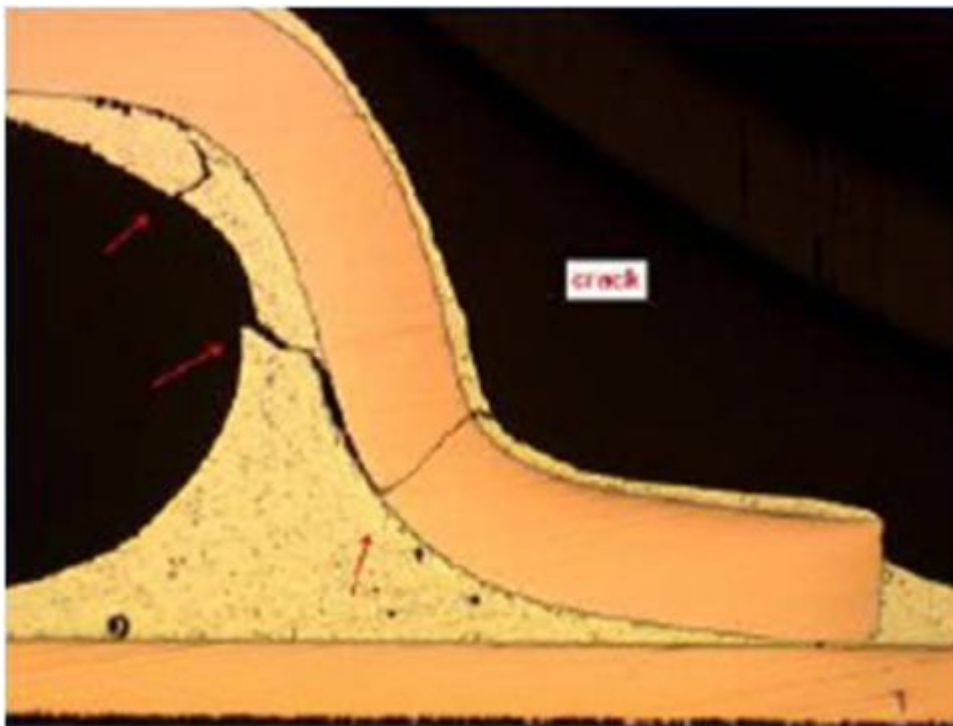
Figure 22 - SN61 U20 Right Lead

Cross-sectioning revealed cracks in the actual copper leads of the TQFP-144 packages. This damage was observed only on parts which were not reworked and therefore the solder joint was Pb-free. This is to be expected as the Pb-free solder is stiffer than the SnPb solder and transfers the stress to the weaker copper leads. Figure 21 and Figure 22 illustrate TQFP-144 packages which were not reworked and therefore contain only Pb-free solders.

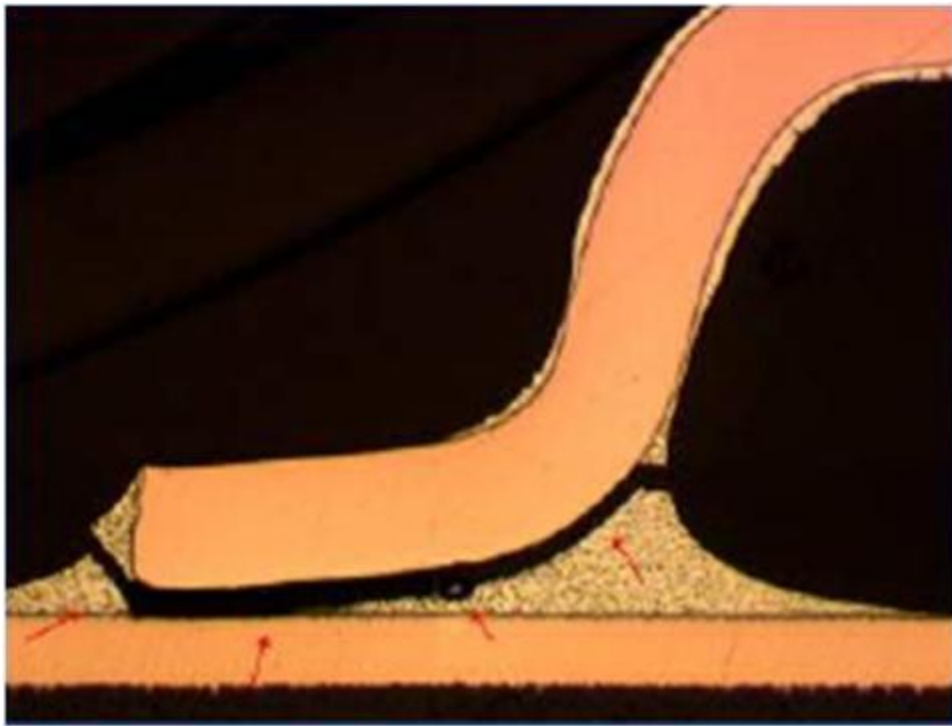
Figure 23 - SN67 U31 Left Lead

Cross-sections of TQFP-144 packages which were re-worked, either once or twice, revealed cracked solder joints in all cases. However, all of the leads on these samples survived see Figure 23 and Figure 24.

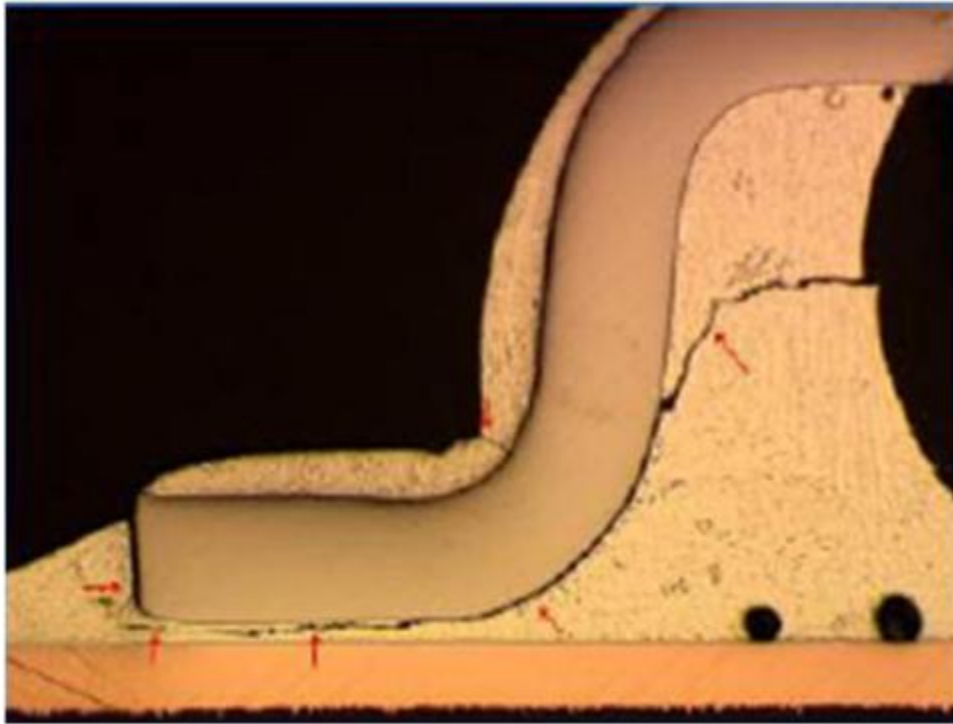
Figure 25 - SN79 U12, Left Lead

SN79 U12 (Figure 25) and SN66 U62 (Figure 26) are examples of TSOPs which did not undergo any re-work. They have Sn and SnBi finishes respectively. Both experienced severe solder joint cracking on both sides of the component.

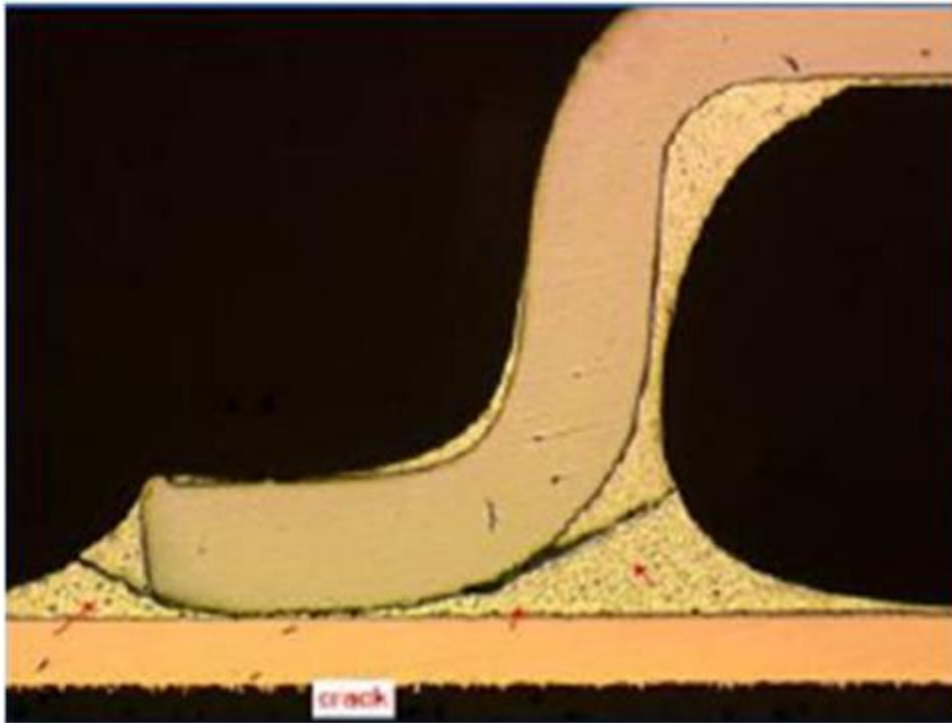
Figure 27 - SN65 U62, Left Lead

SN65 U62 (Figure 27) and SN63 U61 (Figure 28) are examples of parts which underwent one re-work cycle with SnPb solder. They have Sn and SnBi finishes respectively and both components

showed significant cracking within the solder at both sides of the component. This is consistent with all parts which have undergone one re-work cycle.

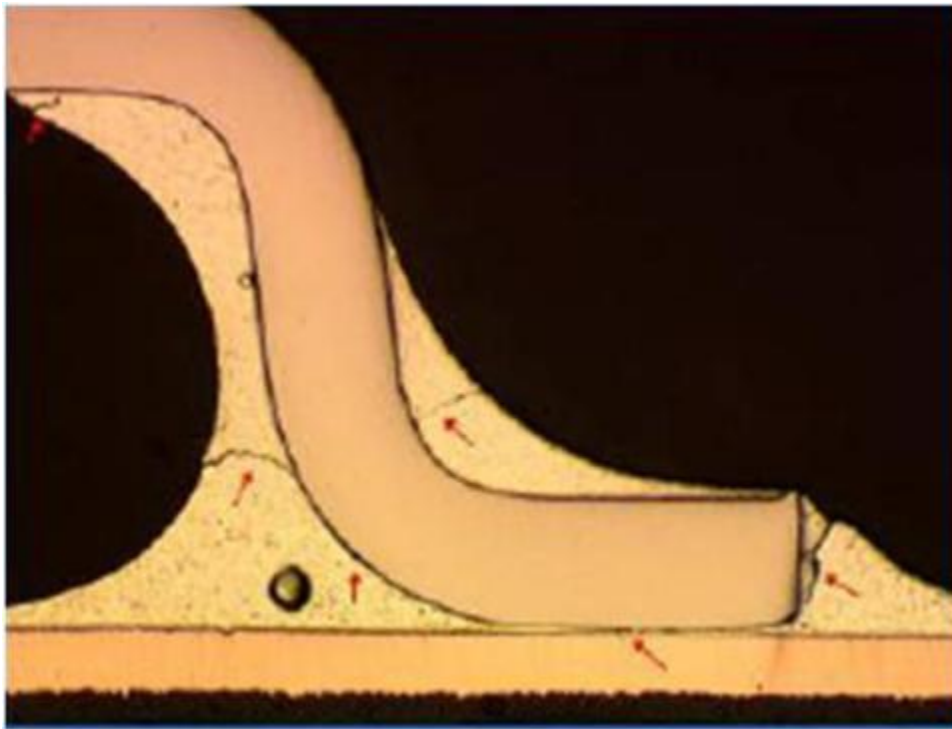
Figure 30 - SN68 U29, Right Lead

SN63 U16 (Figure 29) and SN68 U29 (Figure 30) were both re-worked twice with SnPb solder. SN63 U16 is finished with SnBi and SN68 U29 is finished with Sn. The SnBi part experienced extensive solder cracking through-out. The Sn finished part experienced solder cracking at one side of the component.

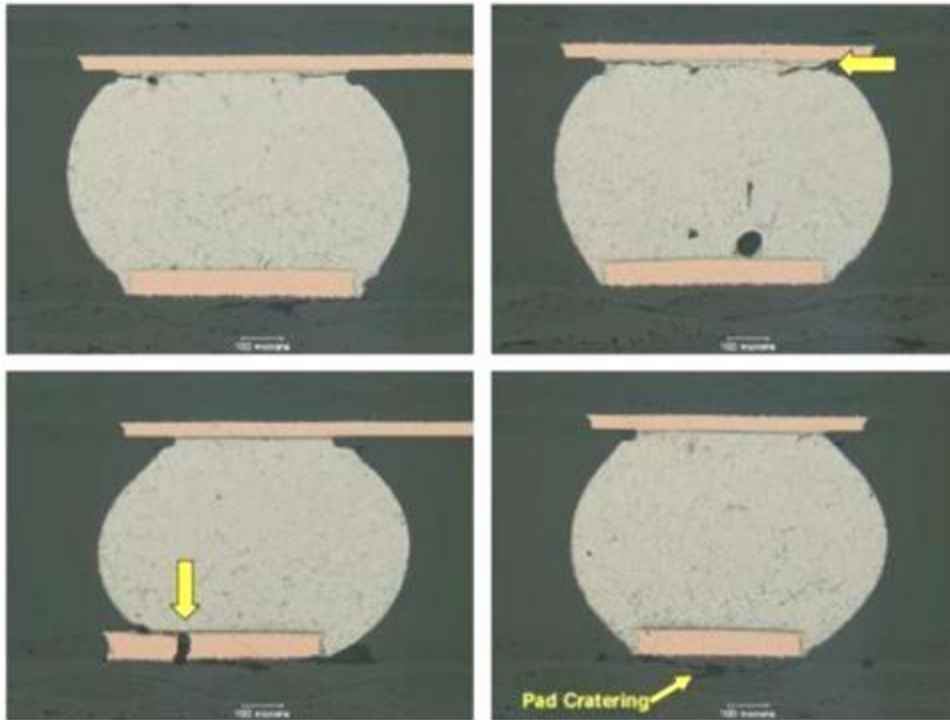
Figure 32 - Test Vehicle 34 - Four Corner Balls of BGA U6 (SnPb Solder/SnPb Balls)

Microsections made at the end of Mechanical Shock Testing showed that the corner solder joints failed first. The SnPb/SnPb sections showed pad cratering, PWB trace cracking, and solder joint cracking on the component side (Figure 32).

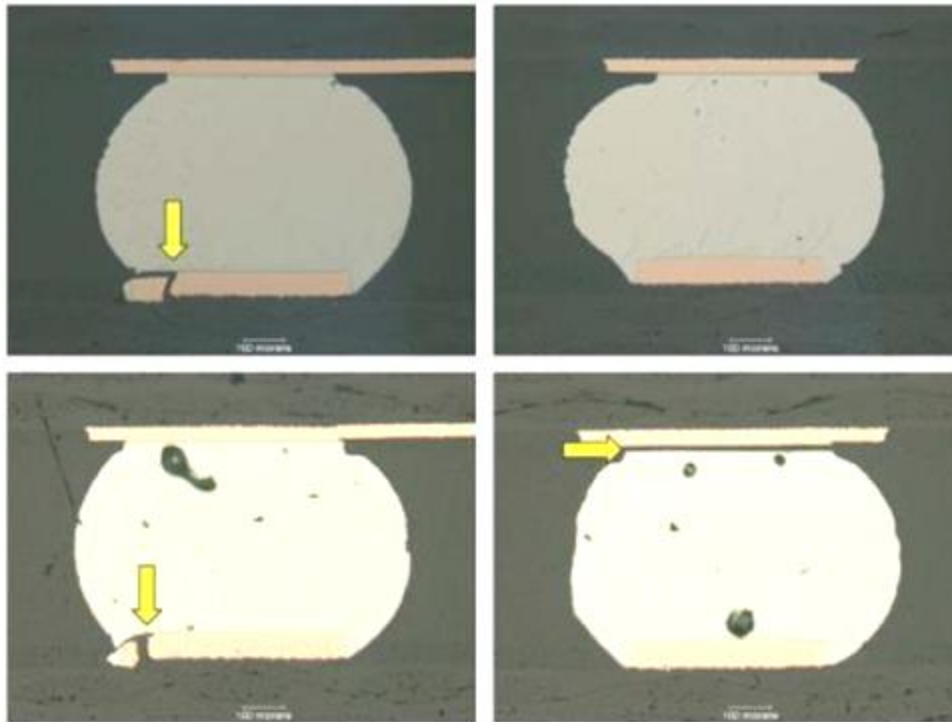
Figure 33 - Test Vehicle 89 - Four Corner Balls of BGA U2 (SAC305 Solder/SAC405 Balls)

The SAC305/SAC405 sections showed PWB trace cracking and solder joint cracking at the component side intermetallic layer (Figure 33). Which failure mechanism occurred first could not be determined from the microsections.

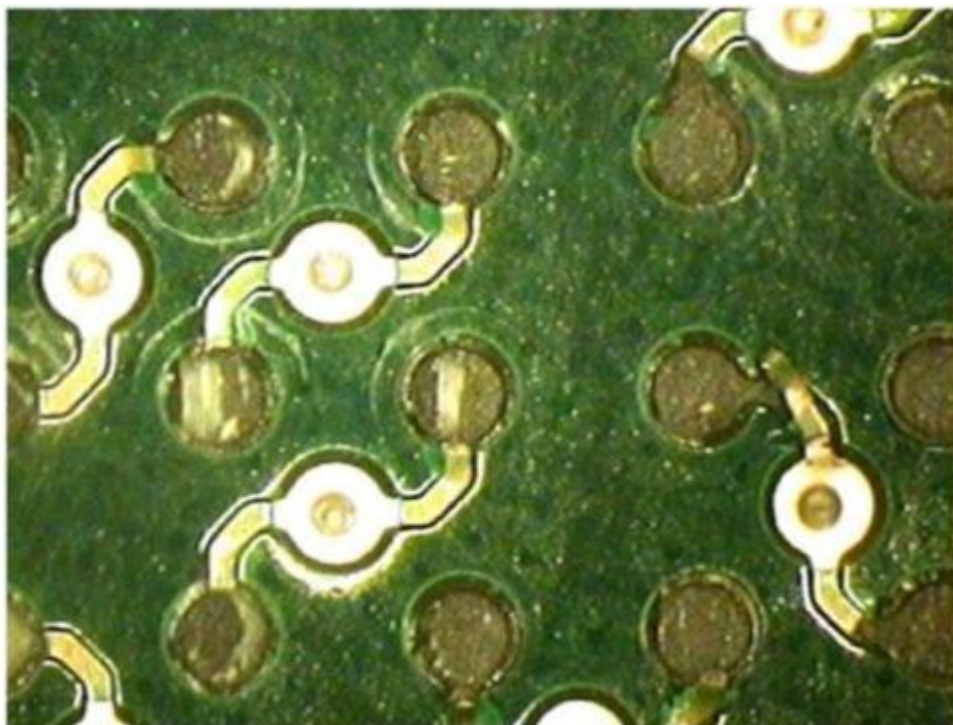
Figure 34 - Test Vehicle 30 BGA U2 with Missing Pads (SnPb Solder/SnPb Balls)

Surprisingly, on the SnPb/SnPb BGA's that fell off, almost 100% of the solder joints failed by pad cratering. The BGA balls and associated PWB copper pads were missing from the test vehicles (Figure 34 and Figure 35).

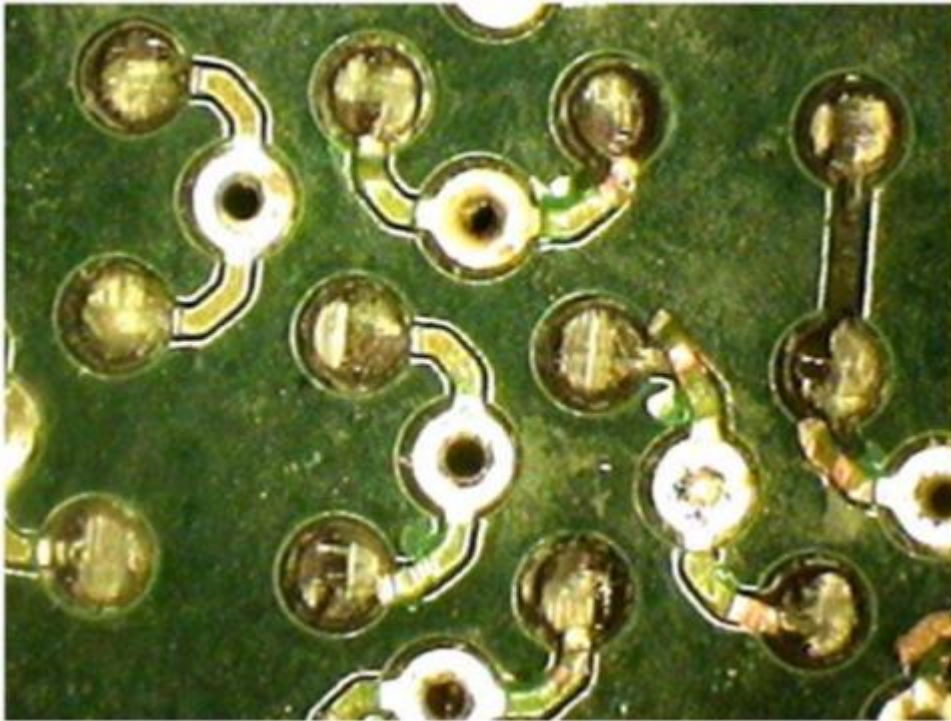
Figure 36 - Test Vehicle 193 BGA U21 with Missing Pads (Flux Only/SAC405 Balls)

No SAC305/SAC405 BGA's fell off during the test. The only purely Pb-free BGA that fell off was one reworked using flux only and a BGA with SAC405 balls. For this BGA, 16% of the

balls remained with the PWB with the solder joints failing on the component side (although most of the remaining balls also showed signs of PWB pad cratering). The balance of the BGA balls and associated PWB copper pads were missing from the test vehicle (Figure 36 and Figure 37).

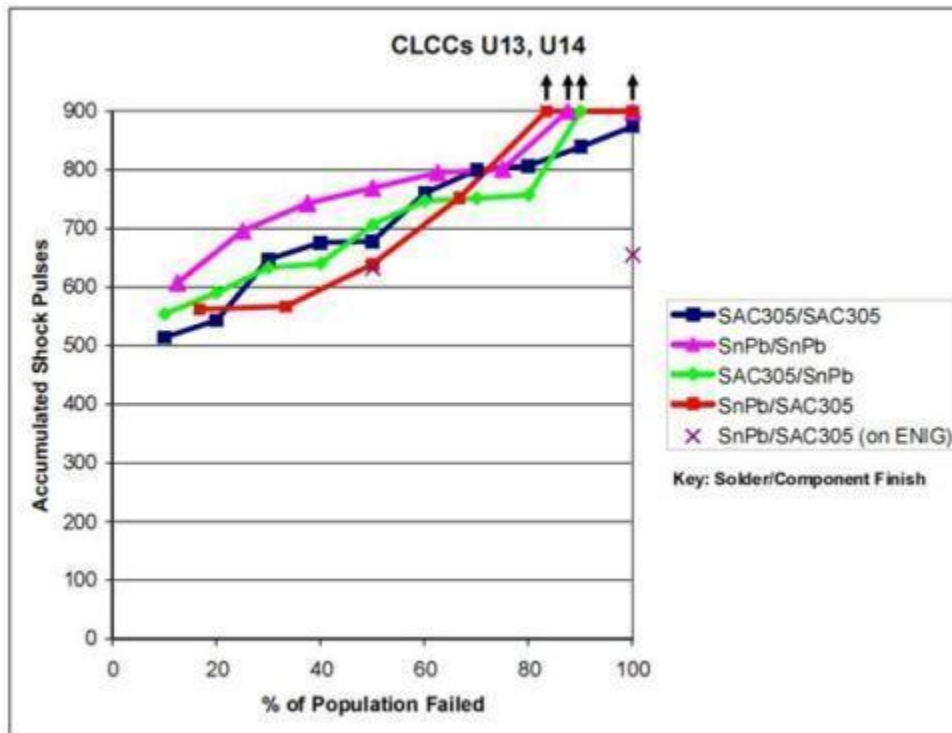
Figure 38 - Combined Data from CLCC's U13 and U14

For the CLCC-20 components, the SnPb/SnPb controls outperformed the combinations of SAC305/SAC305, SnPb/SAC305, and SAC305/SnPb (Figure 38).

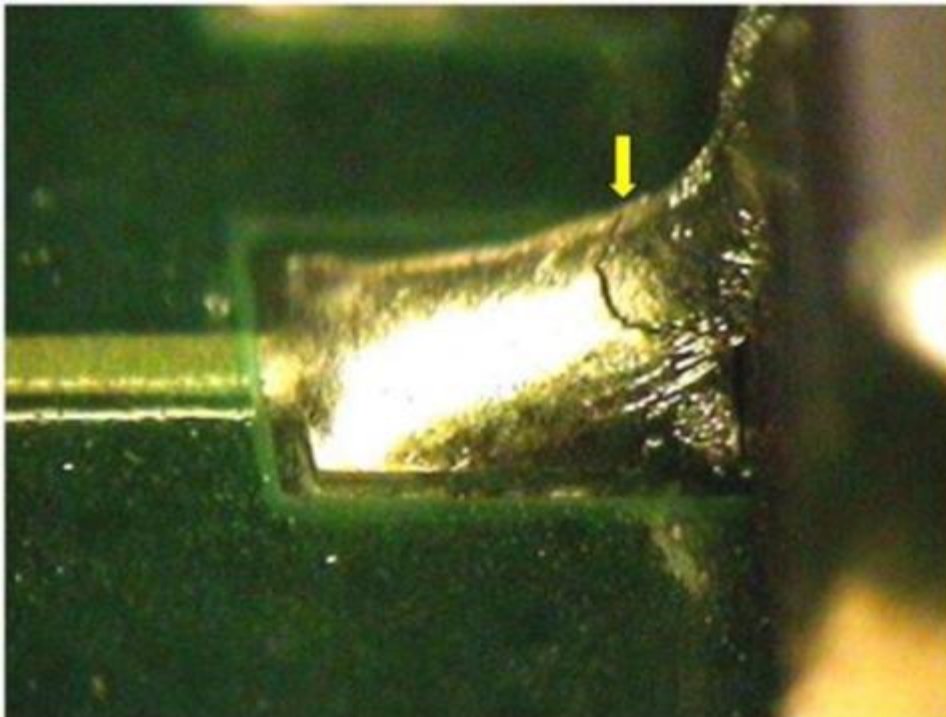
Figure 39 - Test Vehicle 191 CLCC U10 (Cracked SAC305/SnPb Solder Joint)

Test vehicle inspections made at the end of Mechanical Shock Testing showed cracks in a CLCC solder joint (Figure 39).

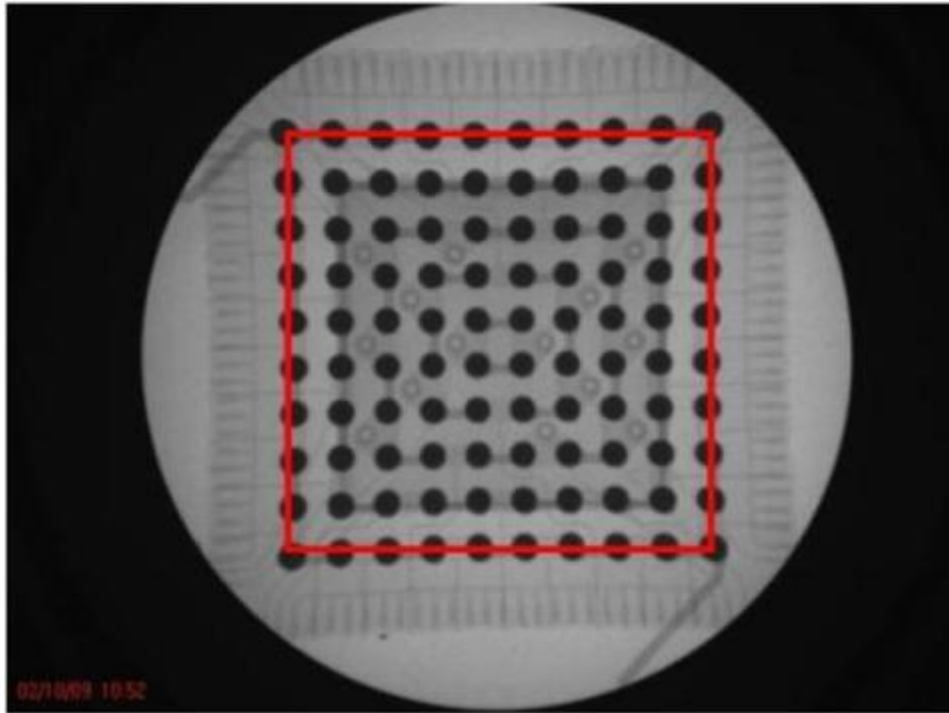
Figure 40 - X-Ray of a CSP-100 (Showing that only the outer balls form a daisy-chain (Red Lines).)

The CSP daisy chain pattern on the test vehicles was incorrect with the result that only the outer perimeter balls of each CSP formed an electrically continuous path (Figure 40). In order for a CSP to be detected as failed, both legs of the outer perimeter needed to fail.

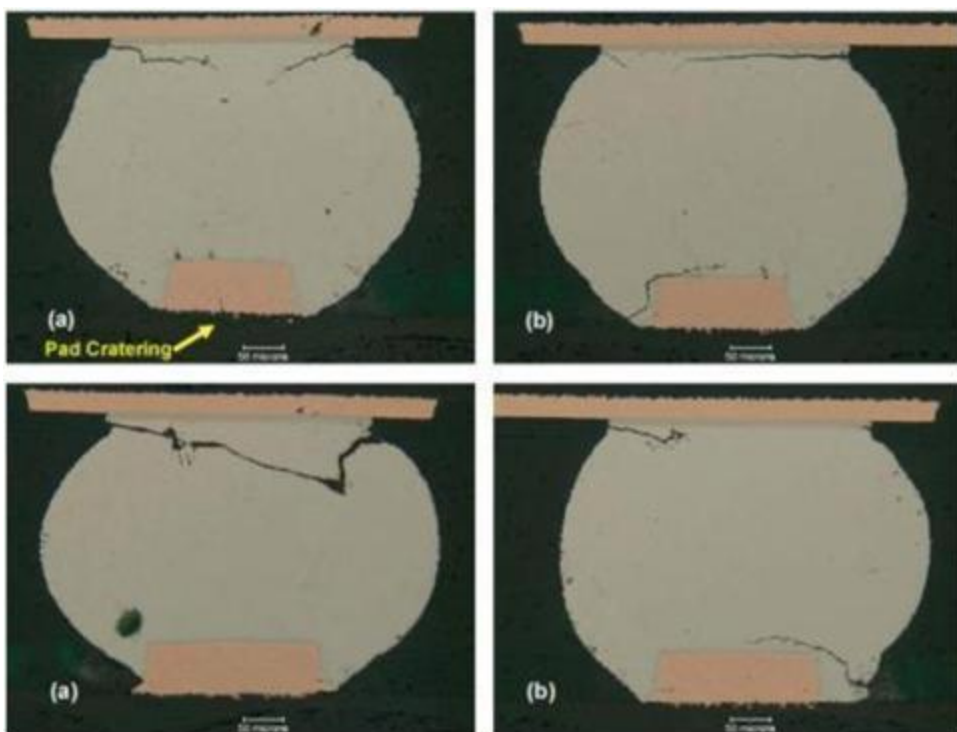
Figure 42 - Test Vehicle 89 – CSP U33

The combination of SAC305 solder/SAC105 balls generally performed as well as the SnPb/SnPb controls in mechanical shock. Microsections made at the end of the test showed that the corner solder joints failed first. The SnPb/SnPb solder joints formed cracks primarily on the component side (Figure 41). The SAC305/SAC105 solder joints formed cracks primarily on the component side and also showed evidence of pad cratering (Figure 42).

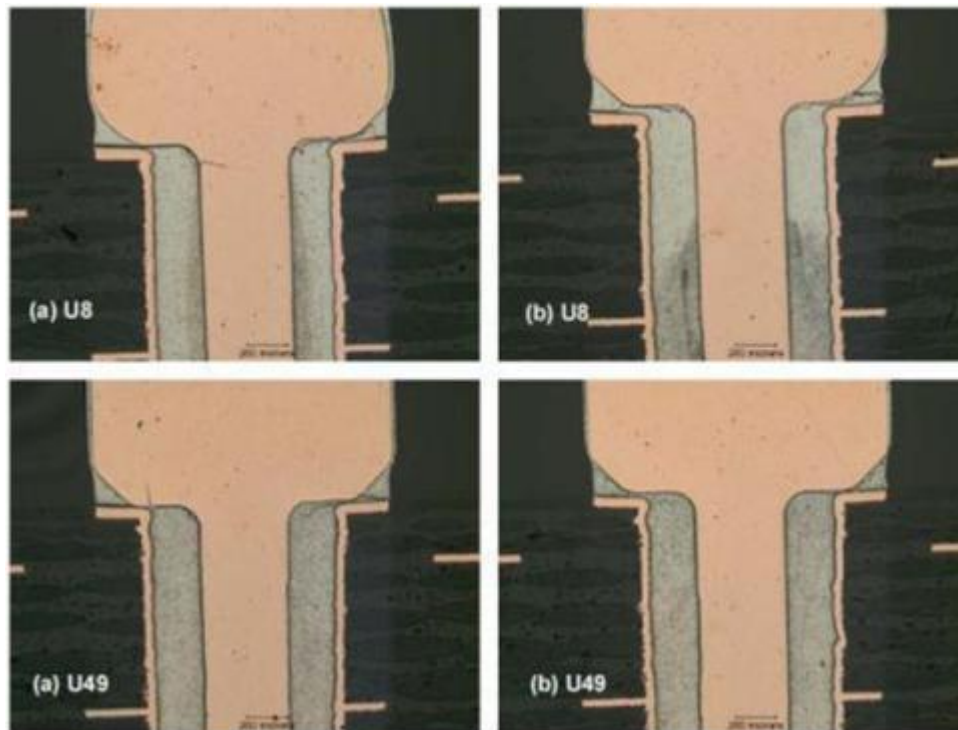
Figure 43 - Test Vehicle 34 – PDIPs U8 and U49 (a) Corner Lead, (b) Lead Adjacent to Corner Lead (SnPb Solder/SnPb Finish)

The combination of SN100C solder/Sn component finish generally performed as well as the SnPb/SnPb controls in mechanical shock although some of the SN100C/Sn solder joints failed early. Microsections made at the end of the test showed that the corner solder joints failed before the other solder joints. The topside solder fillet would crack first followed by cracking of the lead where it necks down at the top of the PTH (Figure 43 and Figure 44).

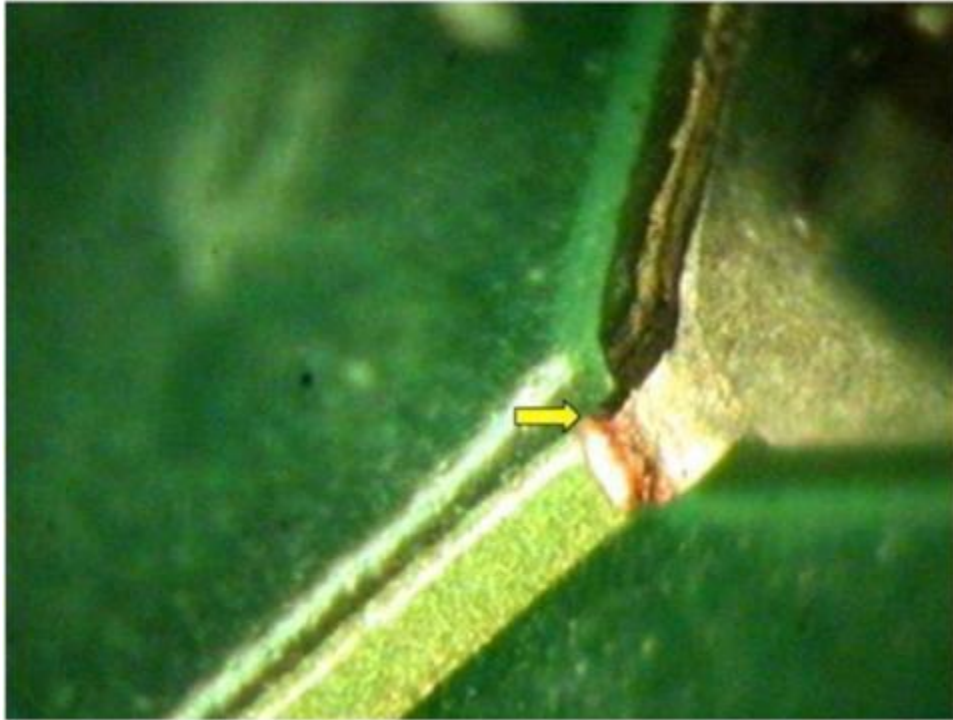
Figure 45 - Test Vehicle 89 PDIP U30 (Cracked Trace, SN100C)

Another observation is that many of the PDIP's soldered with SN100C exhibited trace cracking at the corner solder joints (Figure 45 and Figure 46). This failure mode was not observed as often with the PDIP's assembled with SnPb solder.

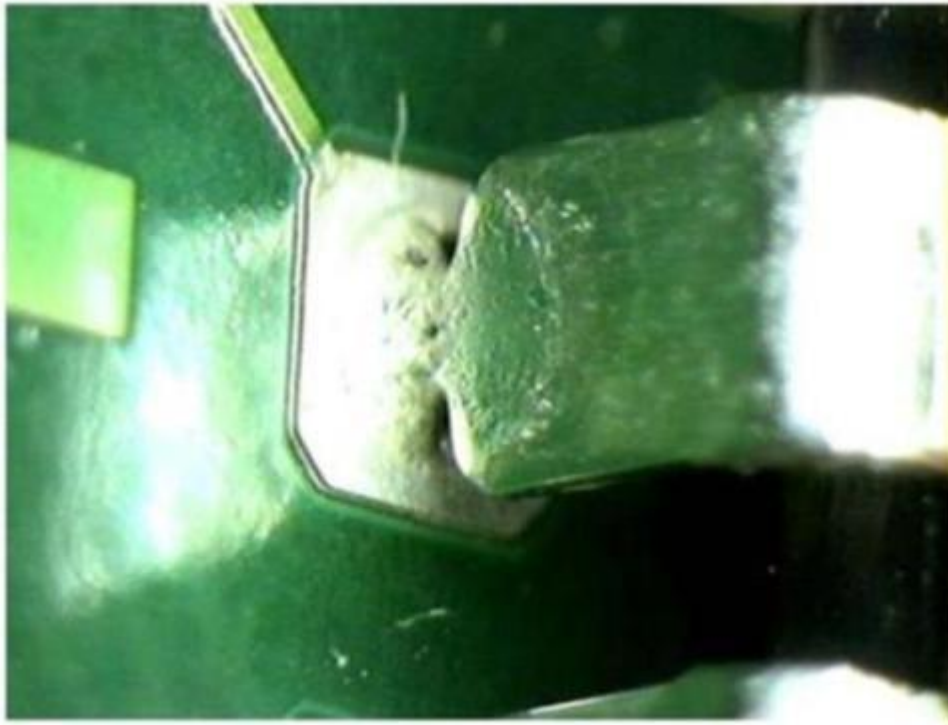
Figure 47 - Test Vehicle 89 PDIP U51 (SN100C)

Several of the earliest failures on the “Manufactured” test vehicles were SN100C/Sn solder joints. One possible cause is that some of the SN100C joints did not have a substantial topside solder fillet (Figure 47). This could have resulted in a point of high stress concentration where the PDIP lead necked down resulting in premature failure of the lead. The trace cracking mentioned above is another possible cause for the early failures. Many of the PDIP’s that failed early exhibited both failure modes so it could not be definitely determined which occurred first.

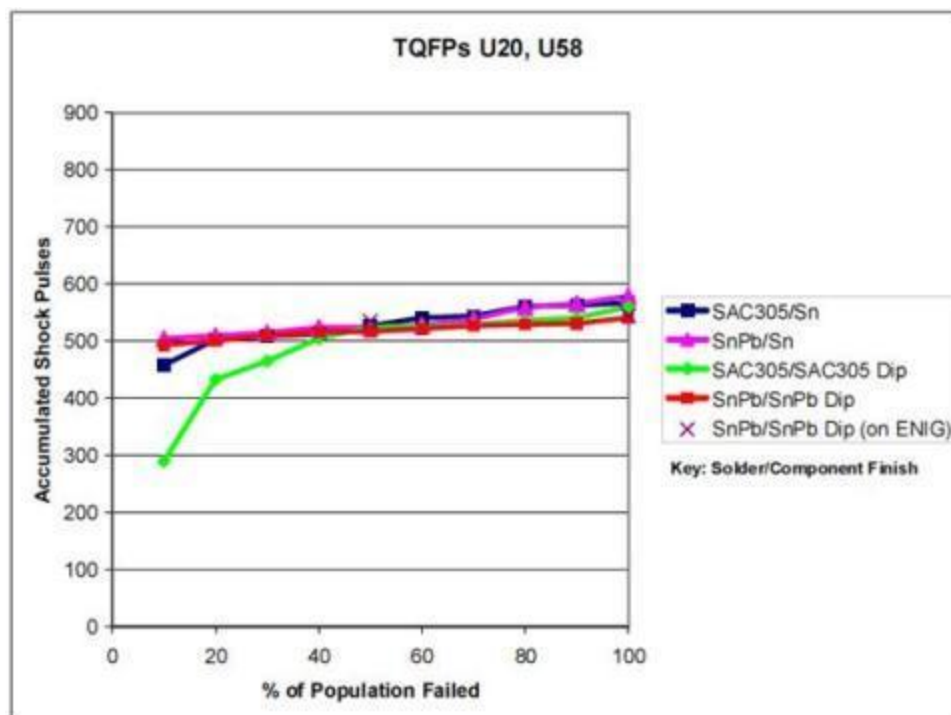
Figure 49 - Combined Data from TQFP's U20 and U58

For this test, some Sn-plated TQFP-144 leads were dipped into either molten SnPb or SAC305 to evaluate the effectiveness of the hot solder dipping on tin whisker formation. The combination of SnPb/SnPb Dip was equivalent to the SnPb/Sn control in performance but the SAC305/SAC305 Dip performance was inferior to that of the SnPb/Sn control due to some early failures (Figure 49).

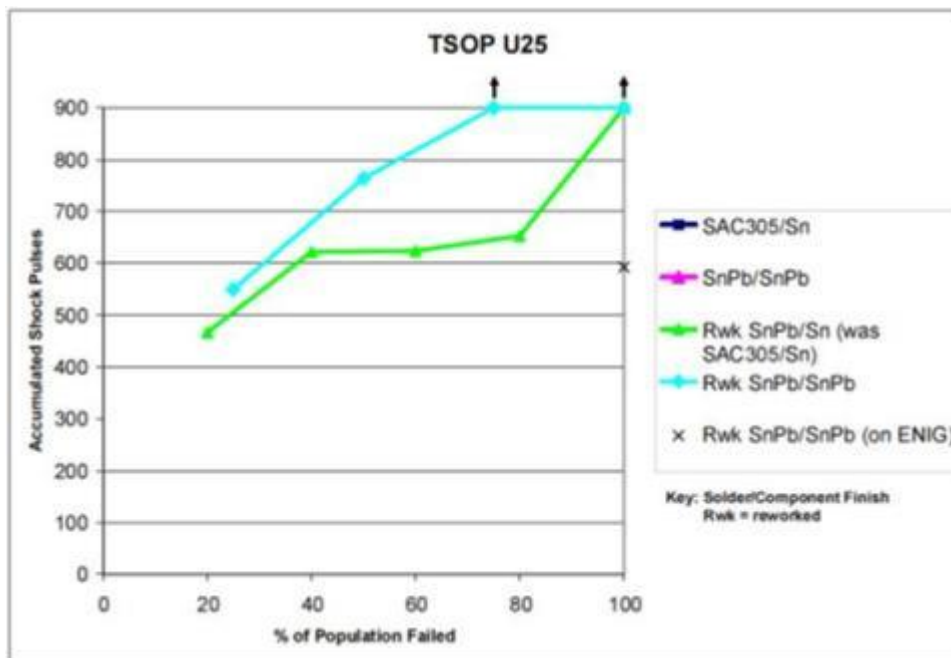
Figure 50 - TSOP U25 Data

Rework had a definite negative effect on performance. SnPb/SnPb reworked with SnPb/SnPb and SAC305/Sn reworked with SnPb/Sn underperformed the un-reworked SnPb/SnPb controls which had no failures (Figure 50).

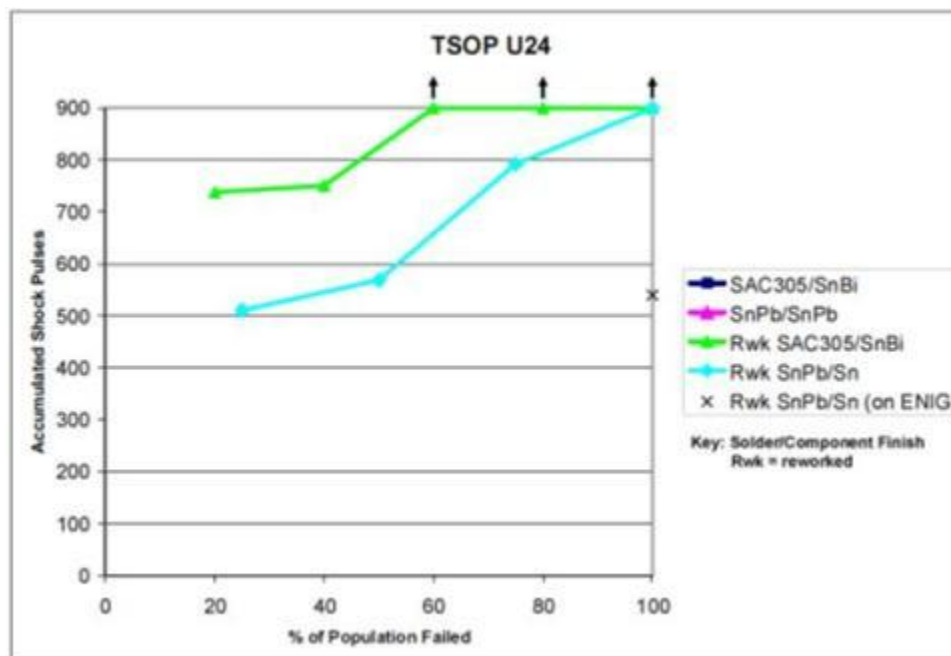
Figure 51 - TSOP U24 Data

SnPb/SnPb reworked with SnPb/Sn and SAC305/SnBi reworked with SAC305/SnBi underperformed the un-reworked SnPb/SnPb and SAC305/SnBi controls which had no failures (Figure 51).

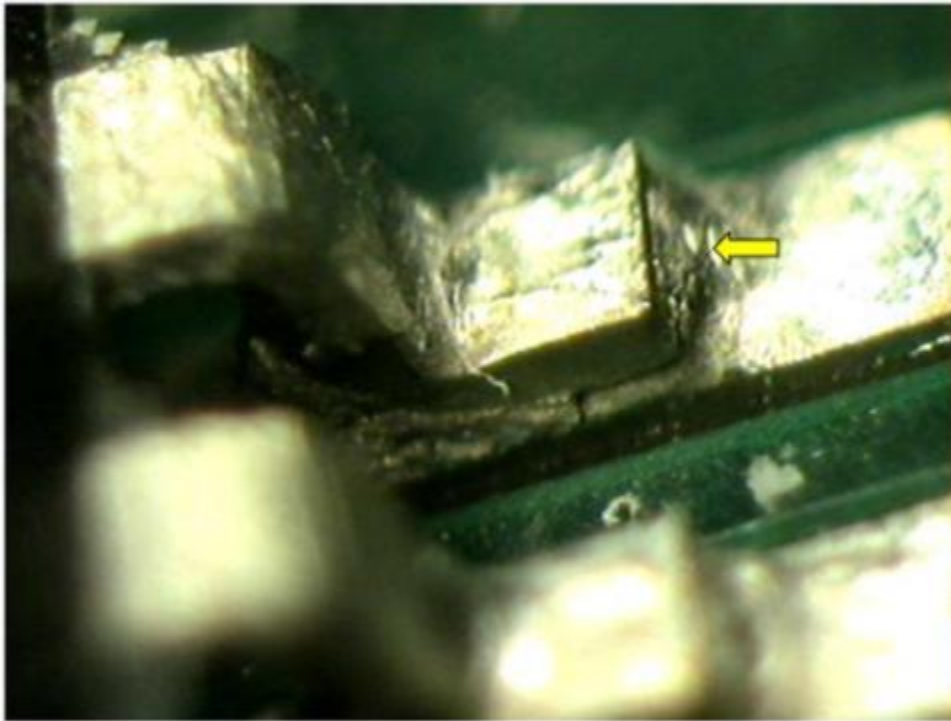
Figure 52 - Test Vehicle 34 TSOP U61 (Cracked SnPb/SnPb Solder Joint)

Test vehicle inspection made at the end of Mechanical Shock Testing showed cracks in a TSOP solder joint (Figure 52).
